DEPARTMENT OF TRANSPORTATION

Office of Structural Materials

Contract #: 04-0120F4Cty: SF/ALA Rte: 80 PM: 13.2/13.9File #: 69.28**WELDING INSPECTION REPORT****Resident Engineer:**Siegenthaler, Peter**Address:** 333 Burma Road**City:** Oakland, CA 94607**Report No:** WIR-021319**Date Inspected:** 02-Mar-2011**Project Name:** SAS Superstructure**OSM Arrival Time:** 700**Prime Contractor:** American Bridge/Fluor Enterprises, a JV**OSM Departure Time:** 1900**Contractor:** Zhenhua Port Machinery Company, Ltd (ZPMC), Changxing Island **Location:** Shanghai, China**CWI Name:** Qiu Wen.**CWI Present:** Yes No**Inspected CWI report:** Yes No N/A**Rod Oven in Use:** Yes No N/A**Electrode to specification:** Yes No N/A**Weld Procedures Followed:** Yes No N/A**Qualified Welders:** Yes No N/A**Verified Joint Fit-up:** Yes No N/A**Approved Drawings:** Yes No N/A**Approved WPS:** Yes No N/A**Delayed / Cancelled:** Yes No N/A**Bridge No:** 34-0006**Component:** OBG components.**Summary of Items Observed:**

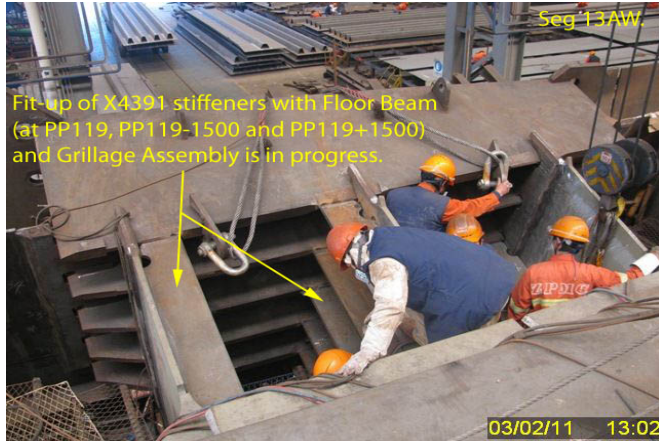
This QA Inspector observed ZPMC personnel performing fit-up of X4391 stiffeners with Floor Beam (at PP119, PP119-1500 and PP119+1500) and Grillage Assembly. Ultrasonic Testing (UT) of FB to Grillage welds is still outstanding. See attached photo for further information.
